July 20, 2018

**Expert Report of Kathryn F. Anderson**  
**Richard Faust, as the Personal Representative of the Estate of K.F.,**  
**Ashley Faust, individually, and Justin Frederick, individually**  
**v. General Motors, LLC, Autoliv ASP, Inc., and Delphi Automotive, LLC**

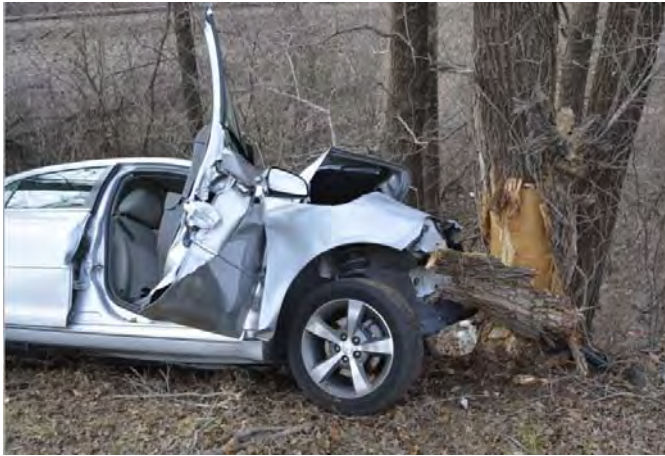
Figure 3 – Police Photo Taken of Passenger (Right) Side of Subject Vehicle at the Crash Scene

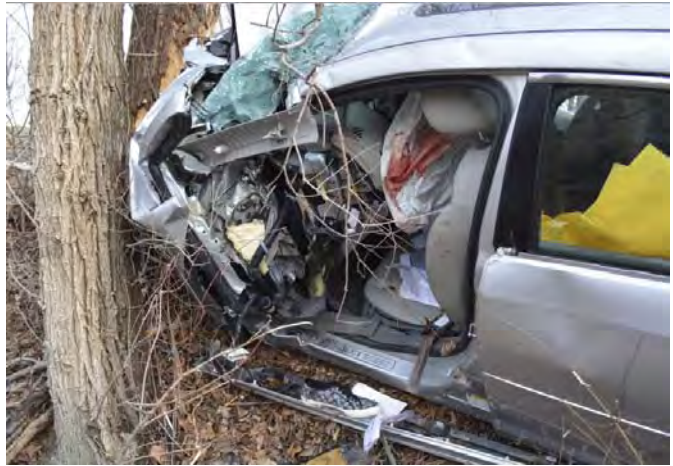
Figure 4 – Police Photo Taken of Driver's (Left) Side of Subject Vehicle at the Crash Scene

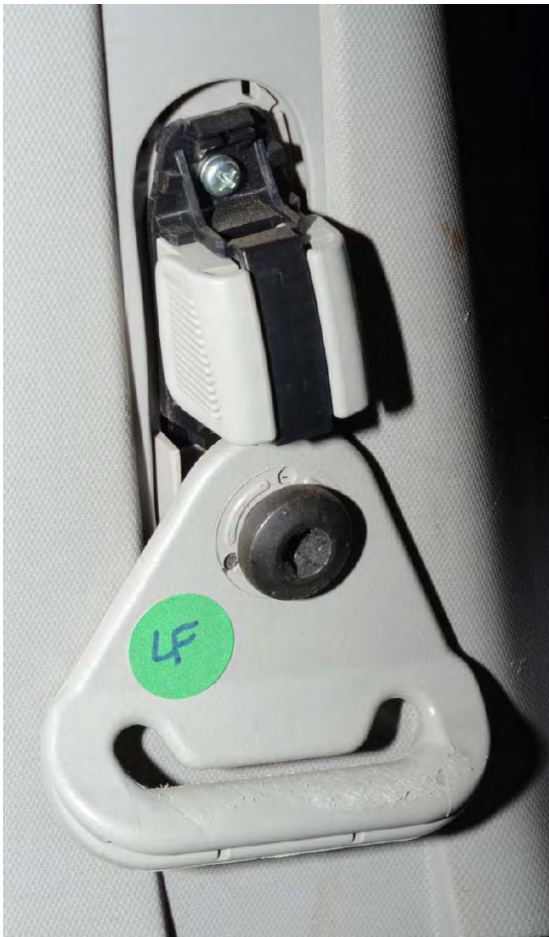
Figure 10 – Anderson Inspection Photo, fau\_251kfa

During my inspection of the interior occupant compartment, I noted that both the driver and right front passenger seat belt pretensioners, and the driver's frontal air bag were deployed. The right front passenger frontal air bag was not deployed. The driver's and right front passenger's seat belts had been cut, and there was evidence of occupant loading on both of the seat belt guide loops (reference Figures 10 and 11).

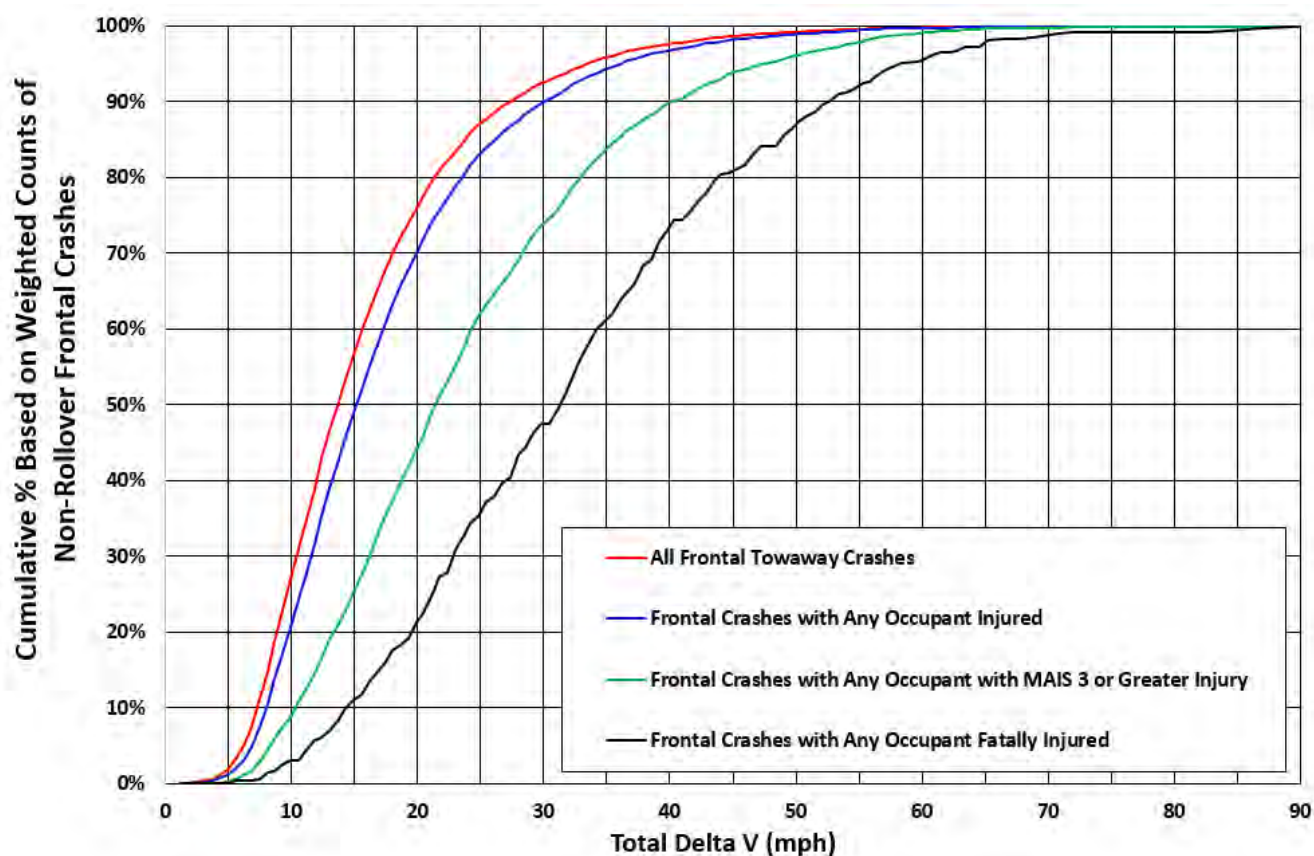
Looking at weighted 2006-2015 NASS-CDS field data, and injuries sustained by occupants in non-rollover frontal crashes where the total change in velocity (delta V) exceeded 65 mph, it indicated that over 99% of crashes of that severity involved an occupant who sustained an AIS 3 (serious) or greater injury, and over 98% of those crashes of such high severity involved an occupant who suffered a fatal injury (reference Figure 20). Considering K.F.'s fatal injuries, I am of the opinion that the severity of her crash (with a maximum longitudinal change in velocity of more than 65 mph) is certainly a contributor to her higher likelihood of sustaining a fatal injury.

Figure 20 –Cumulative Probability of Injury in Cars and Light Trucks in Non-Rollover Frontal Crashes, 2006-2015 NASS-CDS Data
